**REPORT OF ROOF  
INSPECTION:  
CHARACTERIZATION OF  
NEWLY-FABRICATED  
ADHESIVE-BONDED  
SEAMS AT AN ARMY  
FACILITY**

**Walter J. Rossiter, Jr.  
James F. Seiler, Jr.  
Paul E. Stutzman**

**U.S. DEPARTMENT OF COMMERCE  
National Institute of Standards  
and Technology  
National Engineering Laboratory  
Center for Building Technology  
Gaithersburg, MD 20899**

**October 1989**

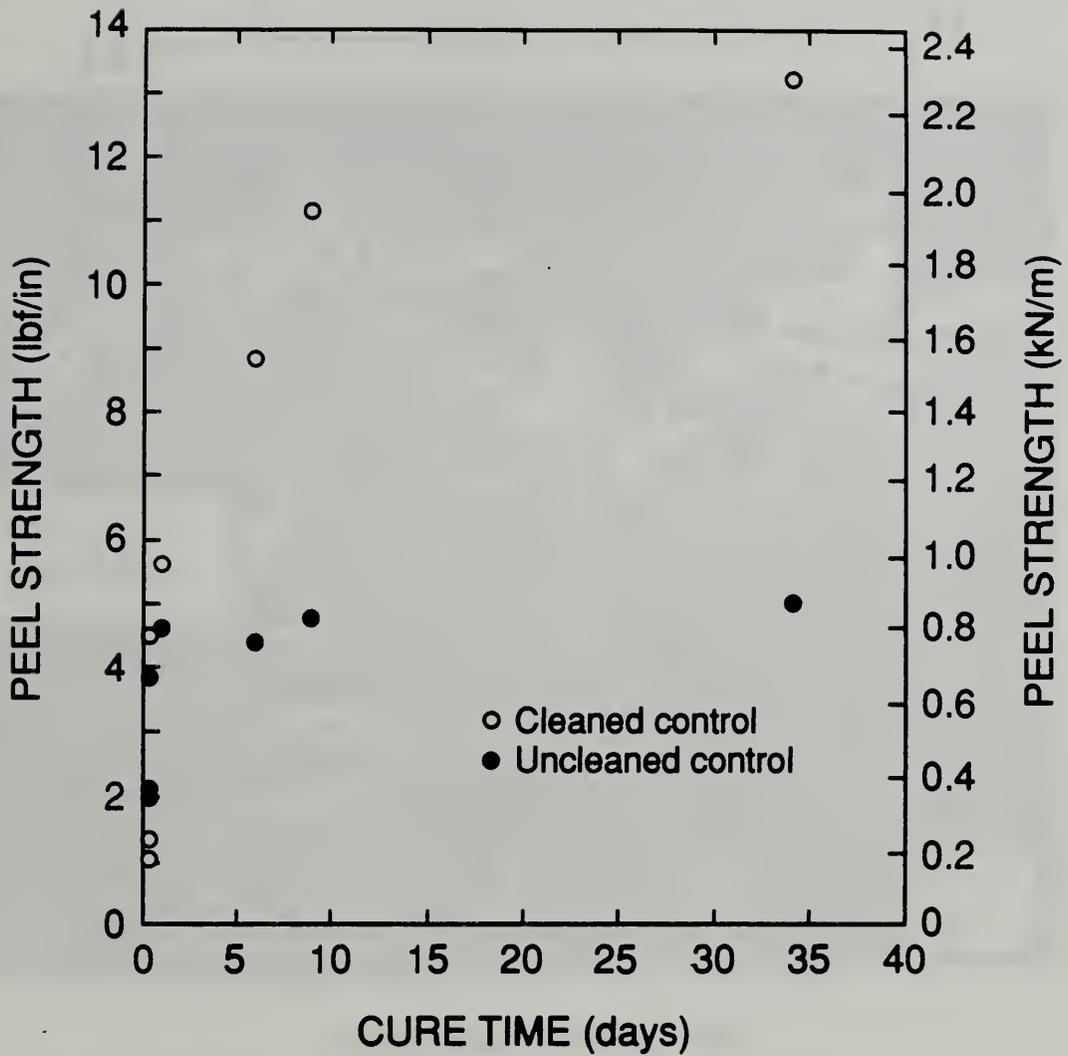
Table 1 gives the T-peel test results for the cleaned and uncleaned control specimens along with the cure (chemical crosslinking) time and the failure mode observed during delamination. The T-peel data include the range, average (four replicates), and variation for each cure time and rubber surface condition. These T-peel data are also presented in Figure 1.

In contrast to the cleaned controls, the uncleaned specimens displayed a relatively constant strength after cure times reached 1 day (Figure 1). Failure during peel testing was generally adhesive (Table 1). As previously observed in the laboratory [10, 13], the cohesive strength of the adhesive layer exceeded the strength of the interfacial bond to the uncleaned rubber surface. For the uncleaned specimens, surface effects were important, and failure during peel testing occurred at the interface of the adhesive and the uncleaned rubber surface.

Figure 1. T-peel strength of the control specimens over time.

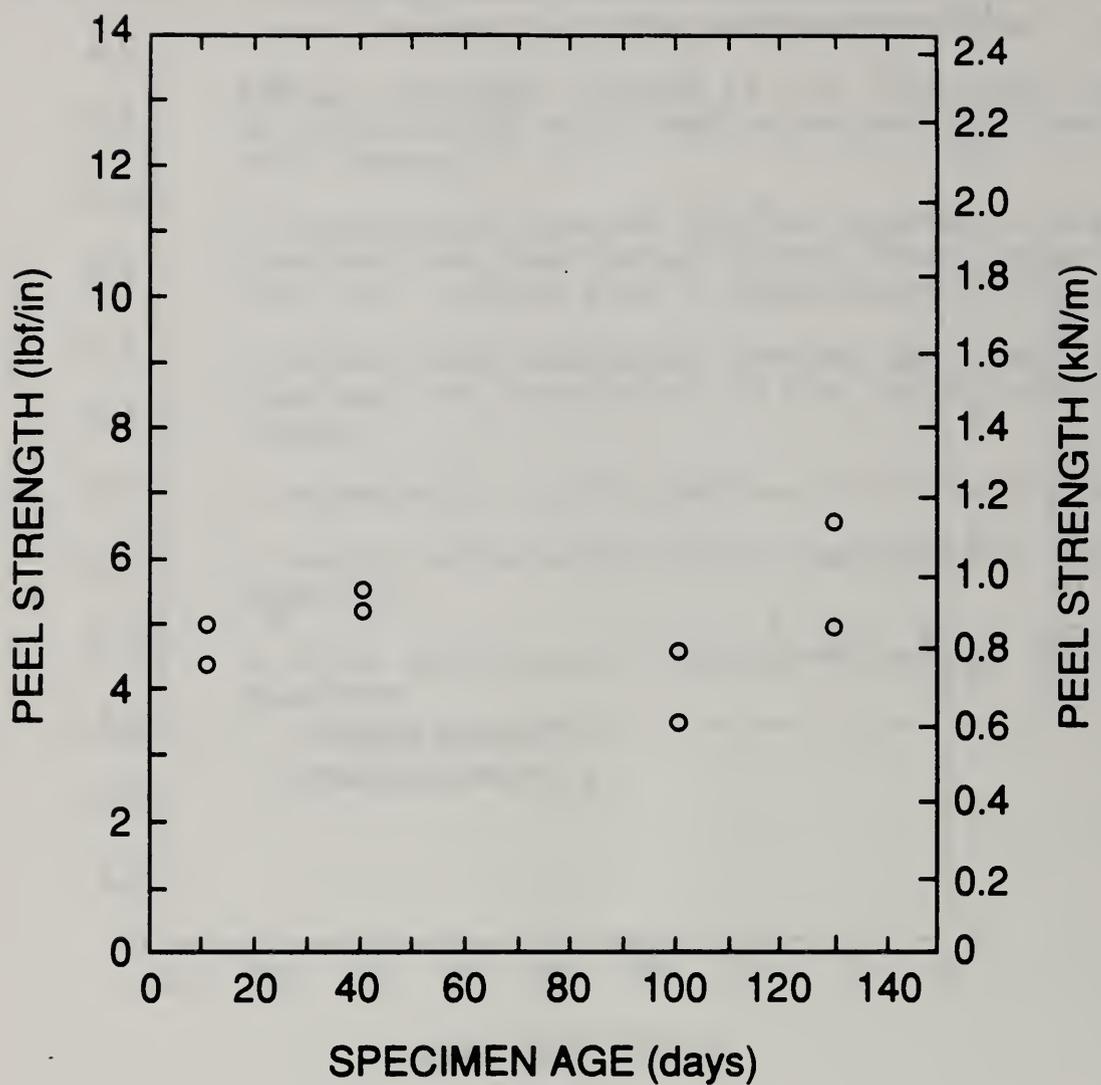
At longer cure times (1 day and beyond), the peel strengths of the cleaned control specimens were significantly greater (0.05 significance level at 1 day; 0.01 or less for longer times) than those of the uncleaned controls. The cleaned controls showed continued strength increase over the time of the experiment

The results of the T-peel tests of the field seam specimens are given in Table 2, and plotted in Figure 2. The field seam specimens were initially tested in the laboratory two days after sampling. Their ages were, thus, 11 and 40 days.

Figure 2. T-peel strength of the field specimens.

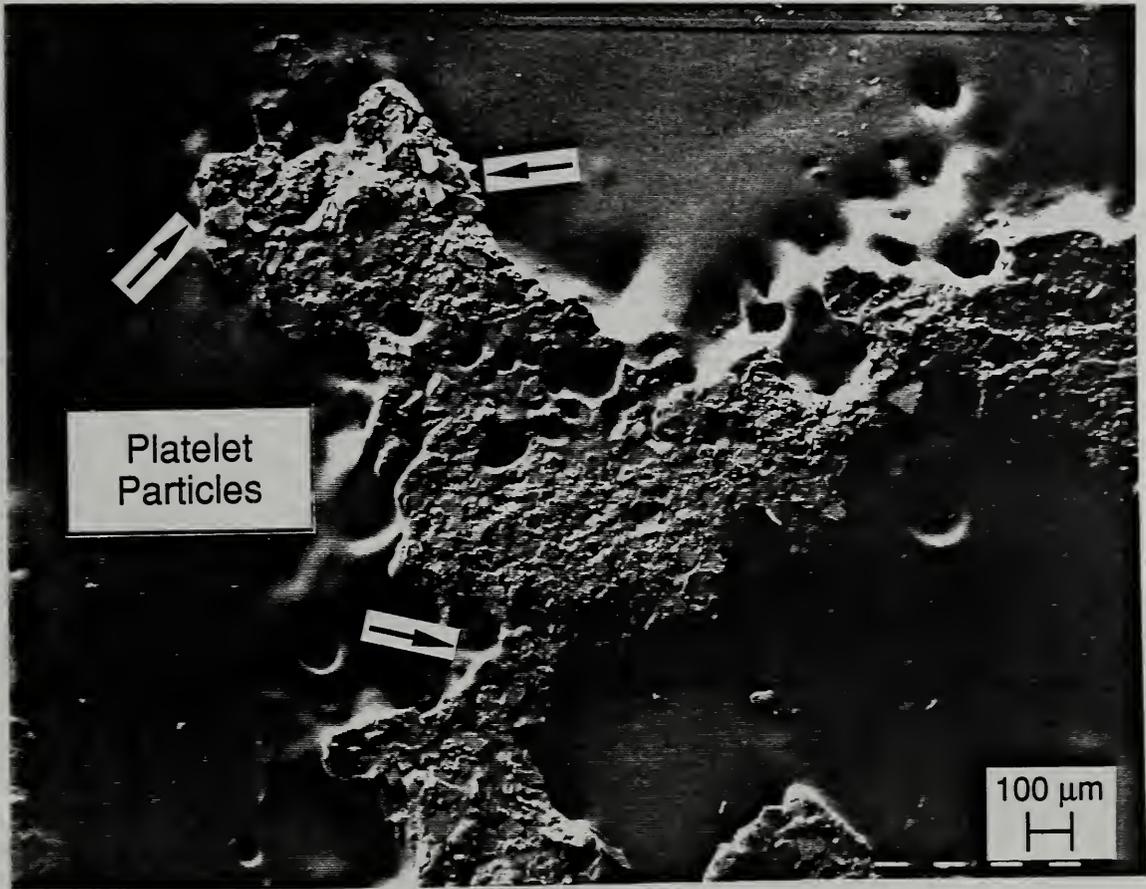
In addition to examining the surface of the adhesive layer where cohesive failure of the field specimens occurred, some areas of adhesive failure were also inspected. In these cases, the corresponding surfaces of the rubber and of the adhesive were subjected to the SEM analysis. Platelet particles indicative of release agent were observed on the surfaces of both the rubber and the adhesive. For example, Figure 3 shows a small section of a field seam where the bond failed adhesively, as indicated by the raised rough area of adhesive in the center of the micrograph. Platelet particles are present on the surface of the adhesive. Similarly, Figure 4 is a photomicrograph of a small section of another field seam where adhesive failure occurred during peel testing, revealing platelet particles apparently on the surface of the rubber. The finding of the platelet particles implied that at least some of the release agent, originally present on the rubber sheet at the time of seam fabrication, was not removed during the cleaning process. Nevertheless, sufficient cleaning apparently occurred so that, in general, the strength of the interfacial bond was greater than the cohesive

- o The SEM observation that platelet particles were present on areas of the field specimens that failed adhesively during peel testing indicated that the field cleaning procedure did not remove all the release agent on the surface of the rubber. Nevertheless, cleaning was sufficient to the extent that the interfacial bond of the seam specimens was generally greater than the strength of the adhesive layer.

Figure 3. Photomicrograph (x100 magnification) of a small section of a field seam where adhesive failure showed the presence of platelet particles on the adhesive surface. The arrows indicate examples of areas having particles.

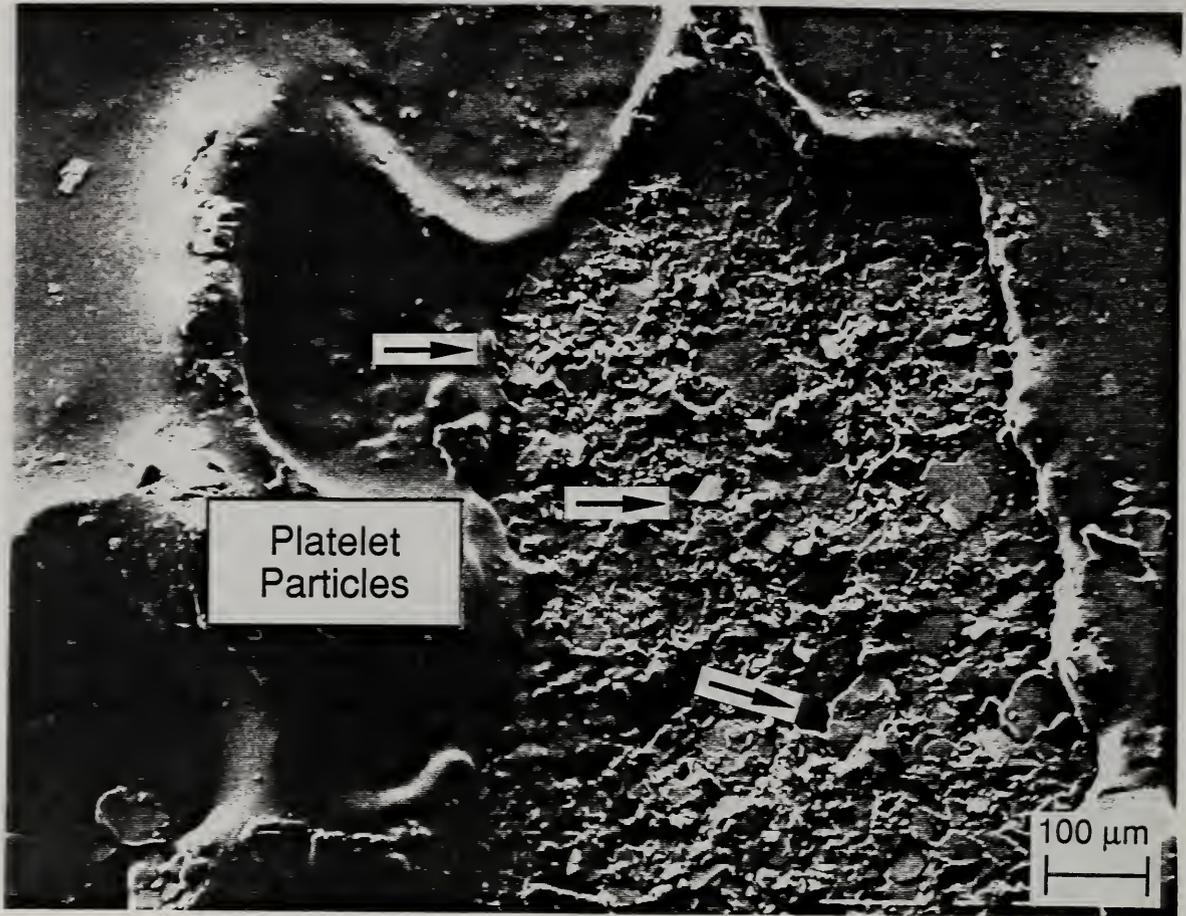
Figure 4. Photomicrograph (x30 magnification) of a small section of a field seam where adhesive failure revealed the presence of platelet particles on the rubber surface. The arrows indicate examples of areas having particles.
